REMOVAL REPORT
FOR
DIAZ INTERMEDIATES CORPORATION SITE
301 WYANOKE ROAD
WEST MEMPHIS, CRITTENDEN COUNTY, ARKANSAS

**REMOVAL ASSESSMENT REPORT
FOR
DIAZ INTERMEDIATES CORPORATION SITE

301 WYANOKE ROAD
WEST MEMPHIS, CRITTENDEN COUNTY, ARKANSAS**

Date Prepared:
October 27, 2008

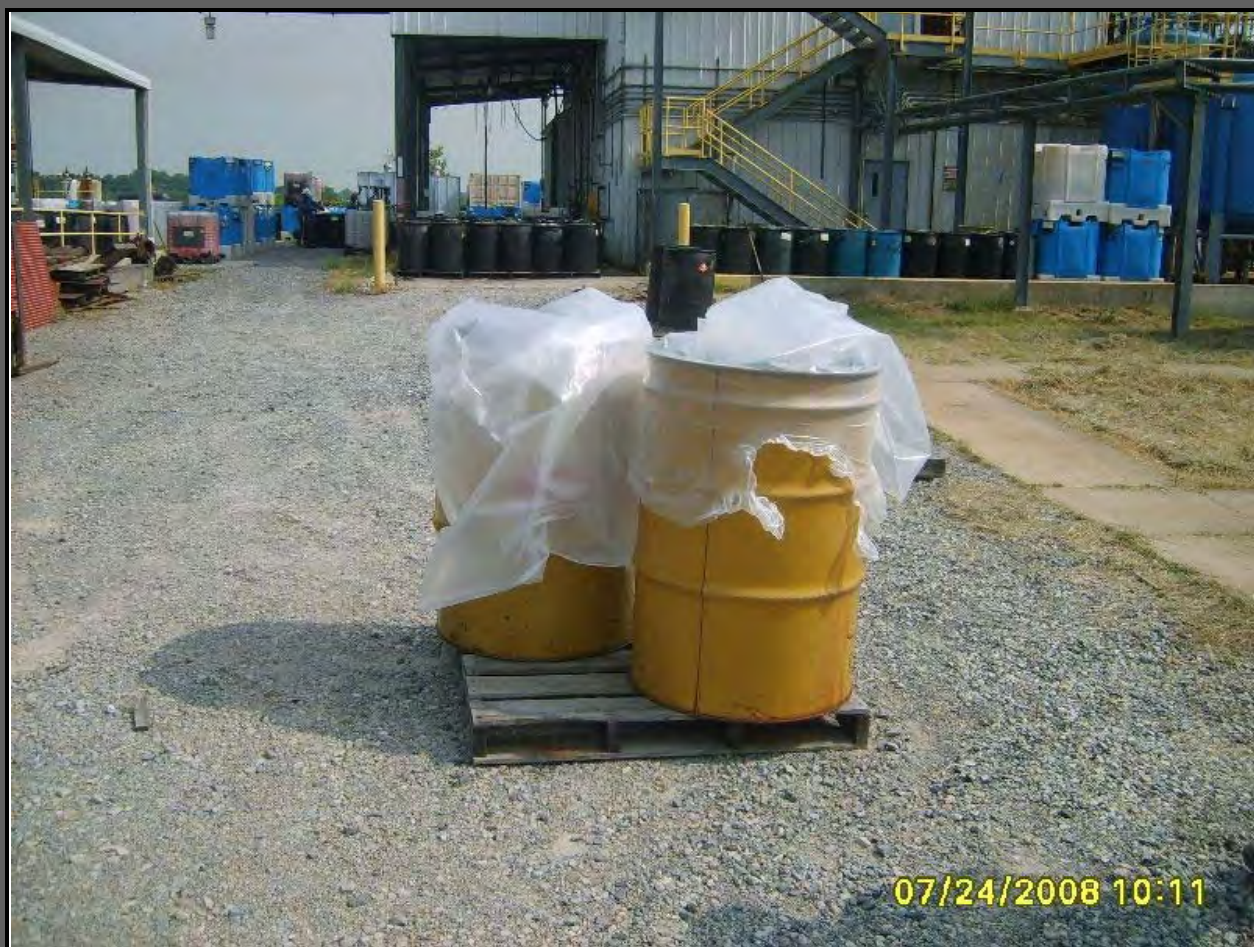
Logbook Photo #	133
US EPA ID / Task Order Number	ARR000005843 / TO-0001-08-01-01
Site	Diaz Intermediates Corporation
Location Address	301 Wyanoke Road
City, State, ZIP code	West Memphis, Arkansas 72301
County	Crittenden
Direction/Orientation	North
Date	07/24/08
Time	1011
Photographer	Steve Cowan, Dynamac START-3
Witness	NA
Description: View of two salvage drums, without lids, containing corroded drums.

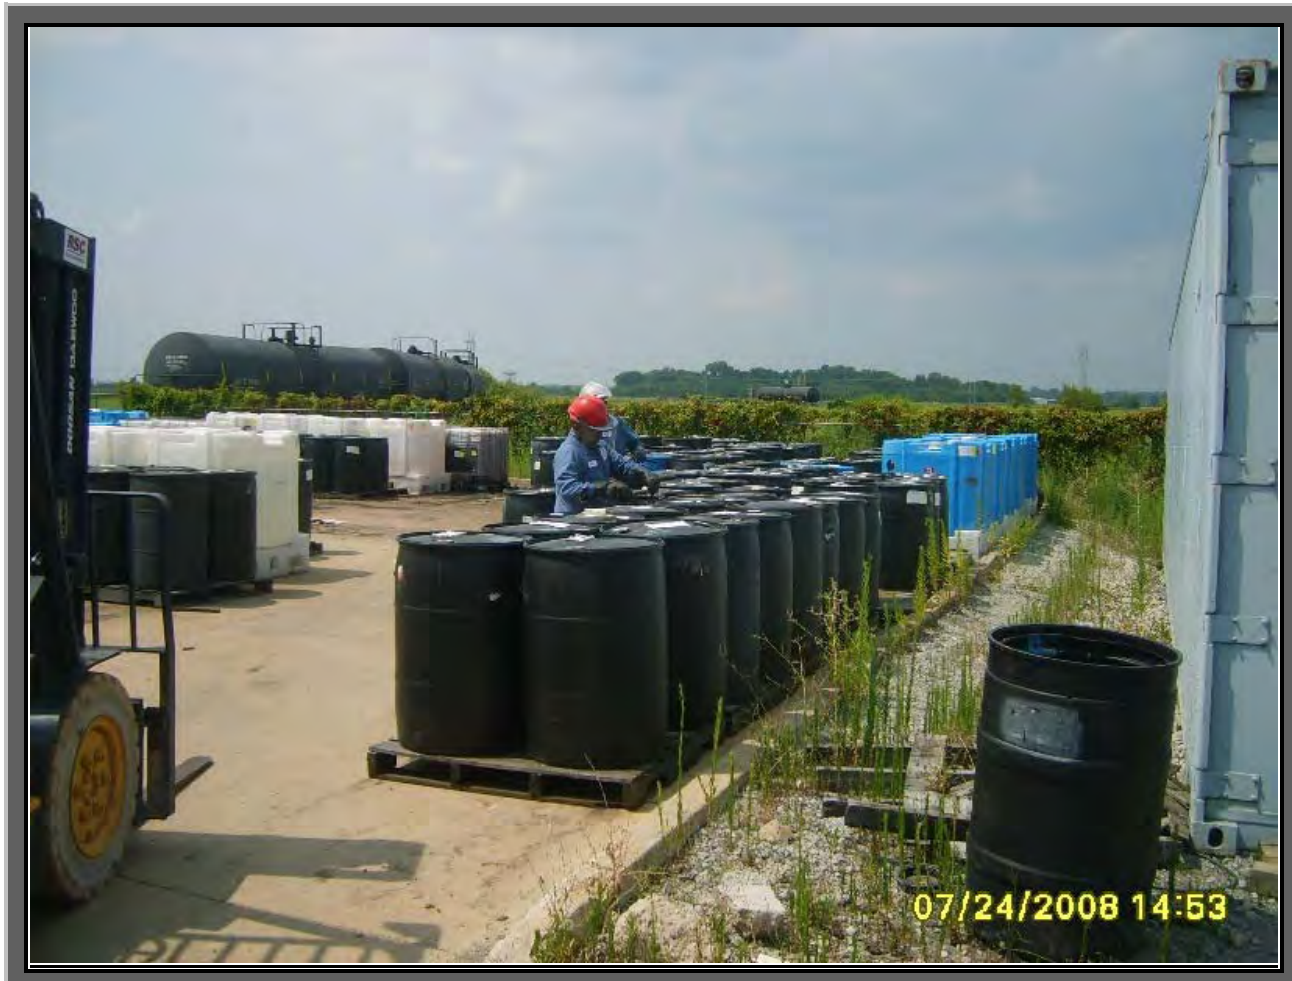
Logbook Photo #	134
US EPA ID / Task Order Number	ARR000005843 / TO-0001-08-01-01
Site	Diaz Intermediates Corporation
Location Address	301 Wyanoke Road
City, State, ZIP code	West Memphis, Arkansas 72301
County	Crittenden
Direction/Orientation	North
Date	07/24/08
Time	1453
Photographer	Steve Cowan, Dynamac START-3
Witness	NA
Description: ERRS changing out drums bungs in Drum Pad area.

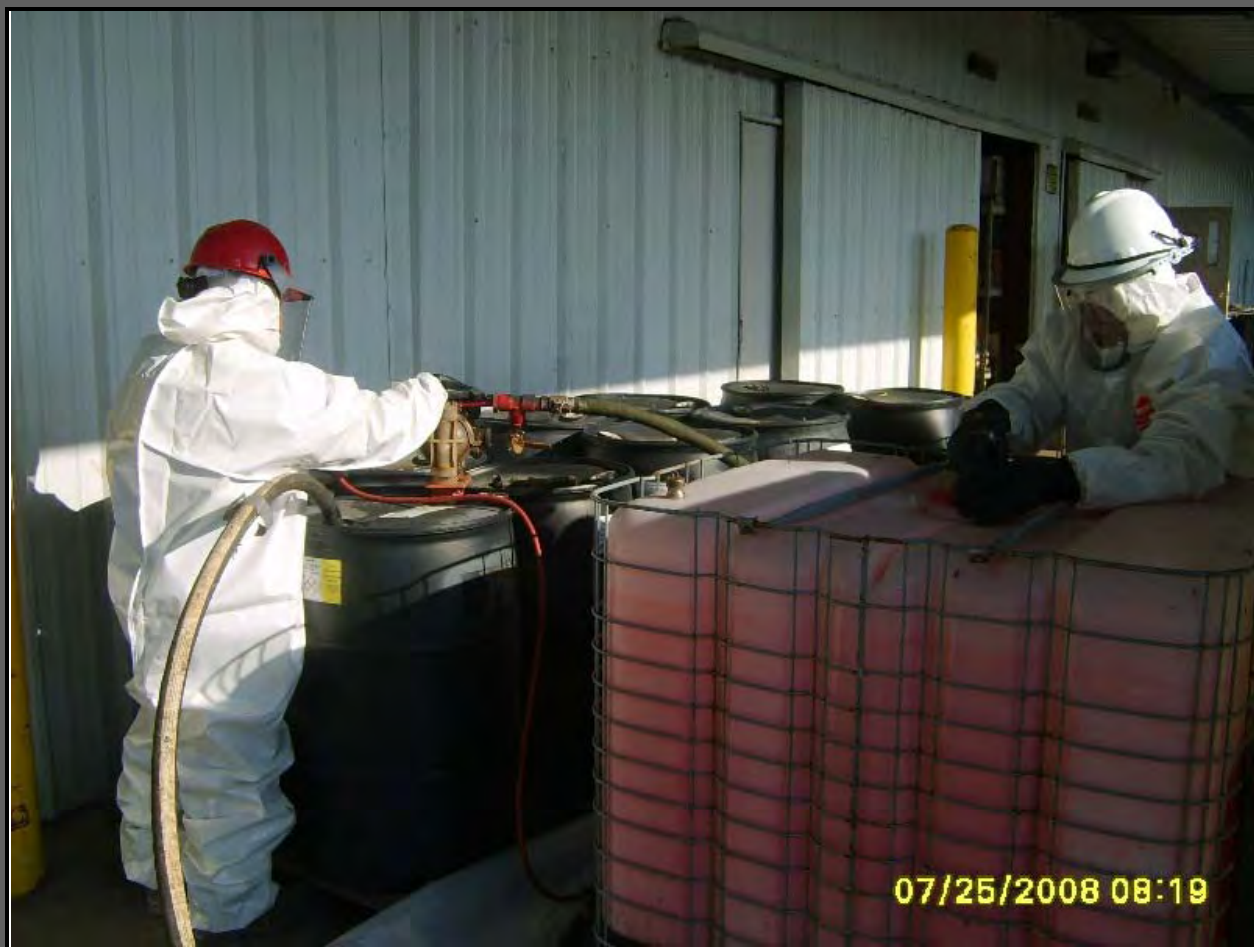
Logbook Photo #	135
US EPA ID / Task Order Number	ARR000005843 / TO-0001-08-01-01
Site	Diaz Intermediates Corporation
Location Address	301 Wyanoke Road
City, State, ZIP code	West Memphis, Arkansas 72301
County	Crittenden
Direction/Orientation	Northwest
Date	07/25/08
Time	0819
Photographer	Steve Cowan, Dynamac START-3
Witness	NA
Description: ERRS transferring the contents of a partially collapse drum into a 250-gallon tote tank.

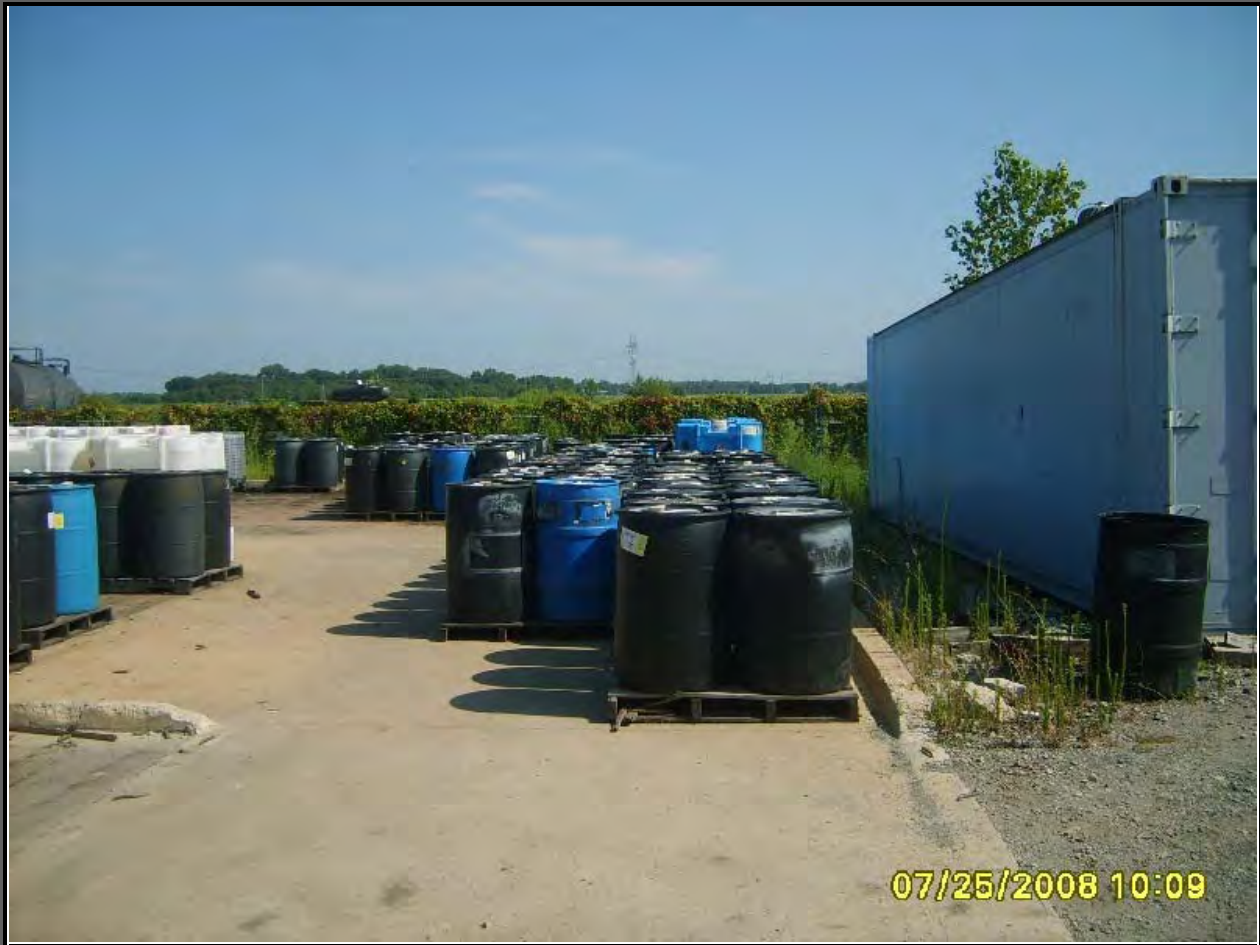
Logbook Photo #	136
US EPA ID / Task Order Number	ARR000005843 / TO-0001-08-01-01
Site	Diaz Intermediates Corporation
Location Address	301 Wyanoke Road
City, State, ZIP code	West Memphis, Arkansas 72301
County	Crittenden
Direction/Orientation	North
Date	07/25/08
Time	1009
Photographer	Steve Cowan, Dynamac START-3
Witness	NA
Description:	View of drums staged in the Drum Pad area.

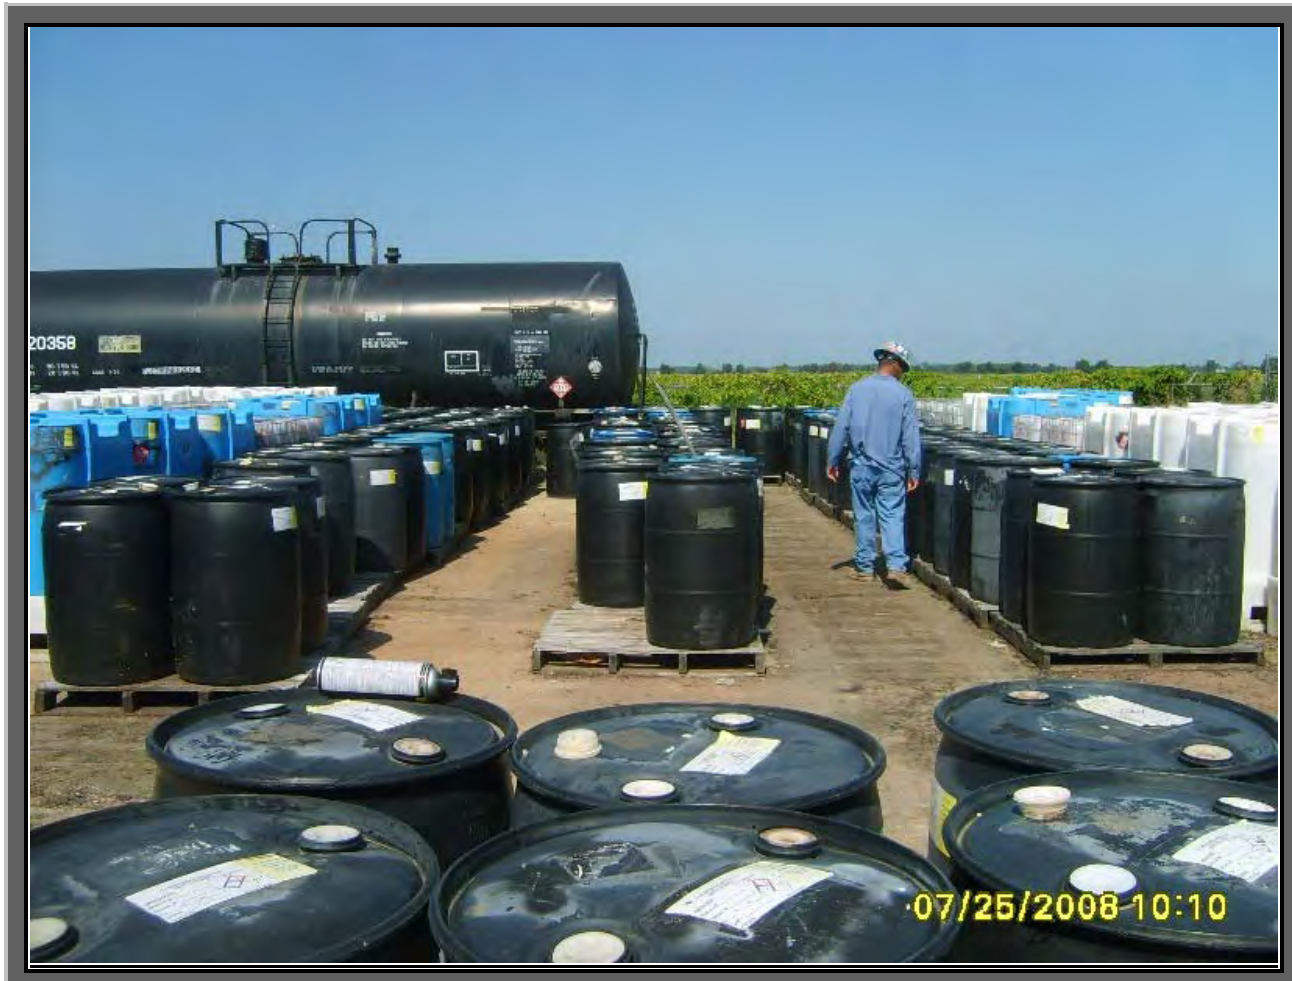
Logbook Photo #	137
US EPA ID / Task Order Number	ARR000005843 / TO-0001-08-01-01
Site	Diaz Intermediates Corporation
Location Address	301 Wyanoke Road
City, State, ZIP code	West Memphis, Arkansas 72301
County	Crittenden
Direction/Orientation	West
Date	07/25/08
Time	1010
Photographer	Steve Cowan, Dynamac START-3
Witness	NA
Description: View of ERRS inspecting the drums staged in the Drum Pad area.

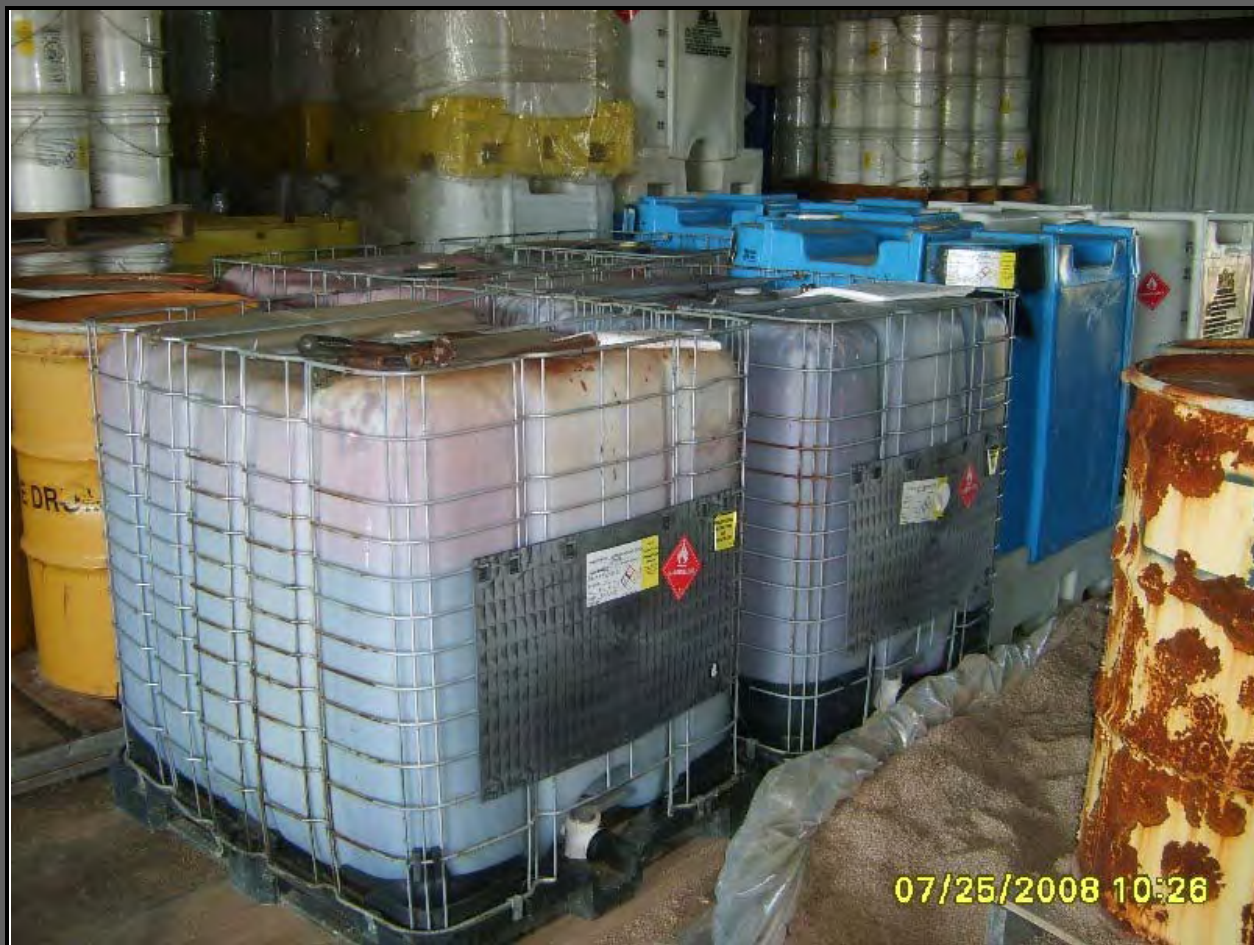
Logbook Photo #	138
US EPA ID / Task Order Number	ARR000005843 / TO-0001-08-01-01
Site	Diaz Intermediates Corporation
Location Address	301 Wyanoke Road
City, State, ZIP code	West Memphis, Arkansas 72301
County	Crittenden
Direction/Orientation	Southwest
Date	07/25/08
Time	1026
Photographer	Steve Cowan, Dynamac START-3
Witness	NA
Description:	View of tote tanks stored in Warehouse containing material transferred from drums.
